NASA Contractor Report 4676

# Effect of Open Hole on Tensile Failure Properties of 2D Triaxial Braided Textile Composites and Tape Equivalents

*Timothy L. Norman, Colin Anglin, David Gaskin, and Mike Patrick*

Grant NAG1-1381  
Prepared for Langley Research Center

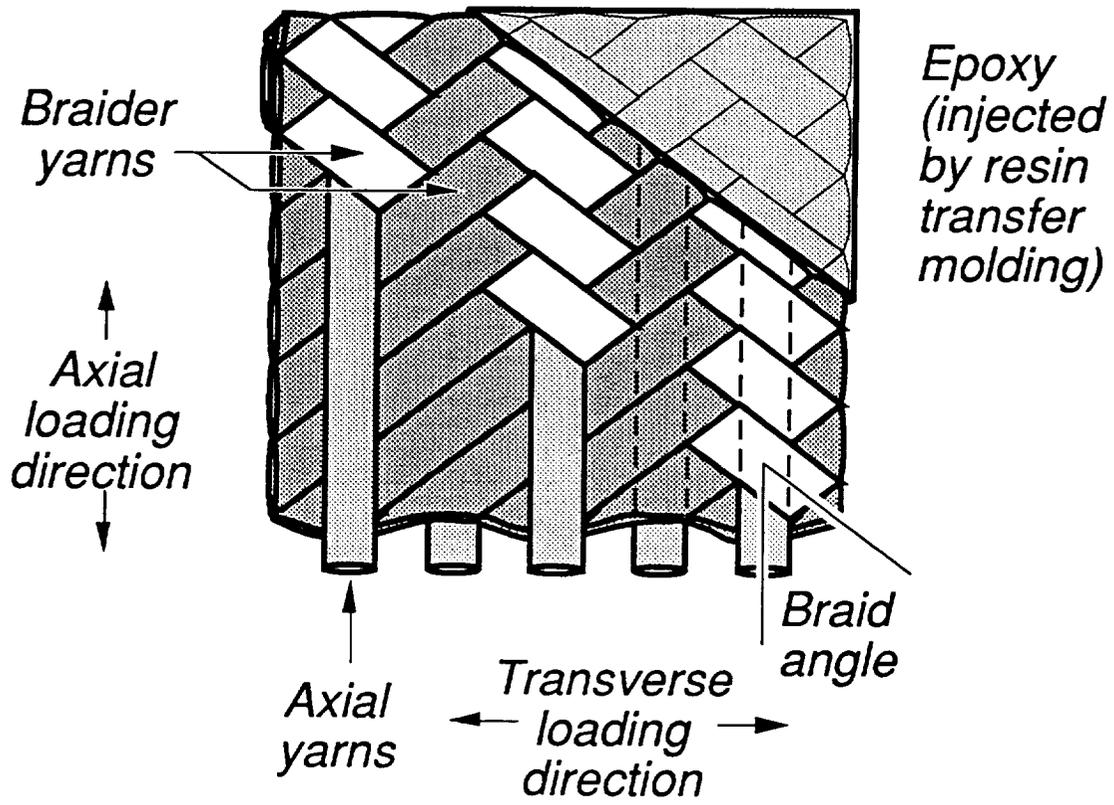
Figure 1. Triaxial braid configuration [13].

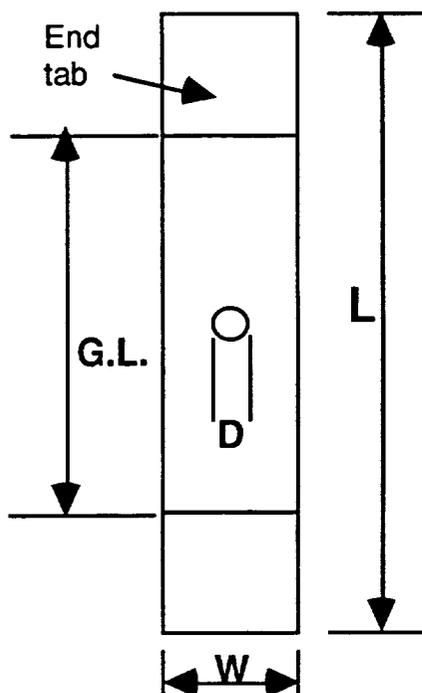
Specimen Width (cm)	L (cm)	G.L. (cm)	D (mm)	G.L./W	W/D
*2.54	15.24	10.16	6.35	4	4
5.08	27.94	20.32	12.7	4	4
10.16	30.48	22.86	25.4	2.25	4

\* dimensions same for unnotched specimens

Figure 2. Notched specimen dimensions.

The 30.48 cm X 60.96 cm plates of nominal 3.175 mm thickness were machined into notched and unnotched coupons (Fig. 2). Coupons were taken from the plates without regard to position or architectural features. All dimensions were recorded. Three different coupon sizes were machined: 2.54 cm wide unnotched and notched, 5.08 cm wide notched and 10.16 cm wide notched. Notch sizes were chosen to maintain a coupon width to hole diameter equal to 4 (W/D = 4). This criterion yields hole sizes of 6.35 mm, 12.7 mm and 25.4 mm for 2.54 cm, 5.08 cm and

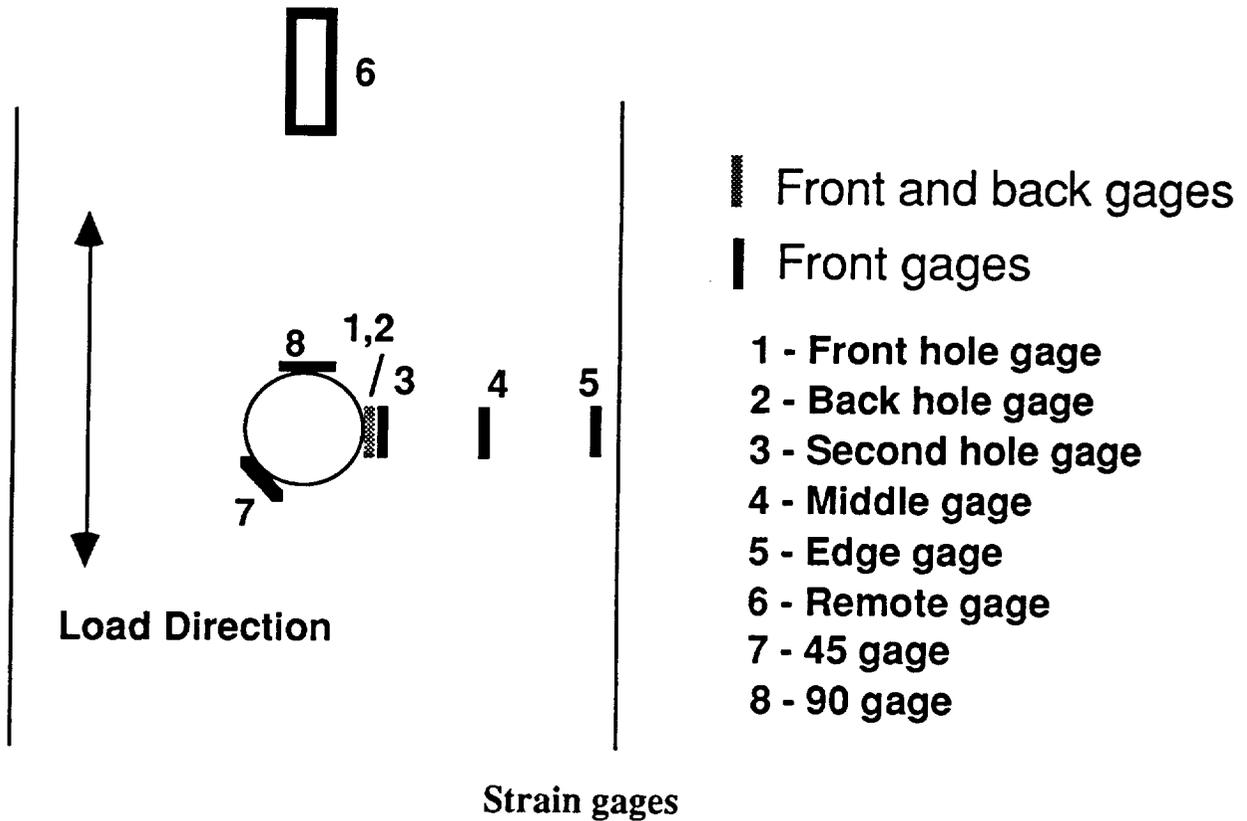
Remote Gage 6  
MM CEA-13-500UW-120 (12.7 mm x 4.6 mm)

Gages 1-5, 2.54 cm (1") Specimen  
EA-13-015DJ-120 (0.38 mm x 0.51 mm)

Gages 7 and 8 all specimens  
EA-13-031-DE-120 (0.79 mm x 0.81 mm)

Figure 3. Strain gage locations for near notch strain measurement.

Specimens of all material types were mounted with strain gages to measure remote strain and near notch normal strain distribution (Fig. 3). For unnotched coupons, strain gages (MM CEA-13-500UW-120) were mounted in the center of each coupon. Remote strain gages for notched specimens (MM CEA-13-500UW-120) were mounted in the center of the coupon half way between the notch and the end tabs. These strain gages measured 4.6 mm in width and 12.7 mm in length which satisfied our criterion that the gage be at least as long as 2 times the unit cell height (Table 2). A total of five strain gages were mounted adjacent to the circular hole to measure the normal strain distribution. EA-13-015DJ-120 gages (0.38 mm x 0.51) were used for 2.54 cm width specimens and EA-13-031DE-120 gages (0.79 mm x 0.81 mm) were used for 5.08 cm and 10.16 cm width specimens. One gage was placed on each side of the specimen as close to the notch as possible, approximately 0.48 mm from center of the gage to the hole edge (x-R) for the 2.54 cm specimen (Fig. 3, Table 5). A third gage was placed approximately 1.3 mm away from the notch for 2.54 cm width specimen. Distances were greater for the 5.08 and 10.16 cm specimens (Table 5). A fourth gage was placed mid-way between the hole and the specimen edge and a fifth gage was placed at 2.54 mm from the specimen edge. Strain gages (EA-13-031DE-120) were also placed at 45° and 90° to the normal of the load direction as close to the hole as possible (Fig. 3).

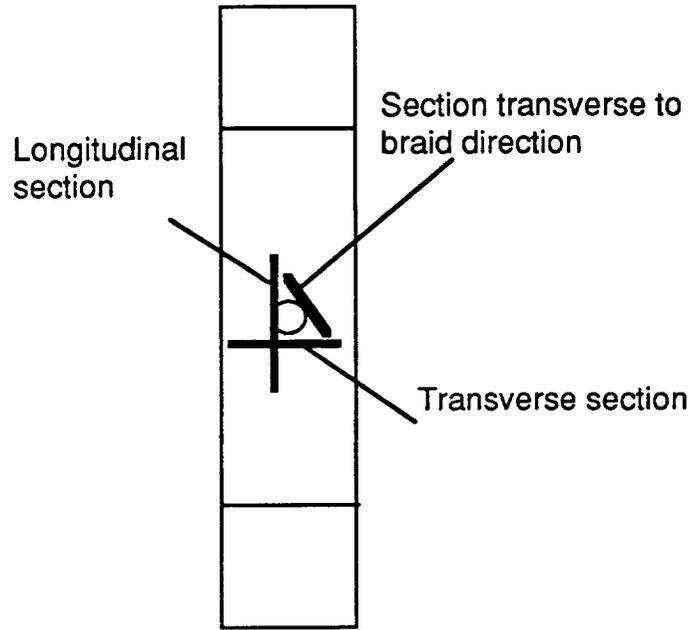
Figure 4. Orientation of sections taken for photomicrographs.

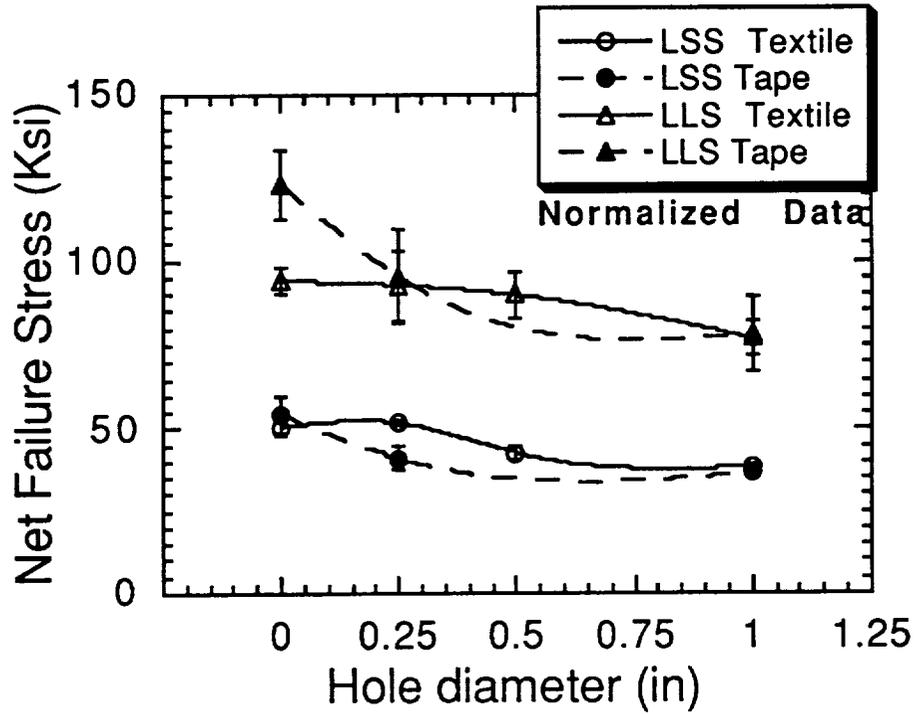
Figure 5. Net failure stress of LSS and LLS textile and tape equivalents.

Net failure stress of notched and unnotched textile and tape equivalent coupons are shown in Figs. 5-7 and Table 7. The net failure stresses have been normalized to 60% fiber volume fracture according to the following equation:

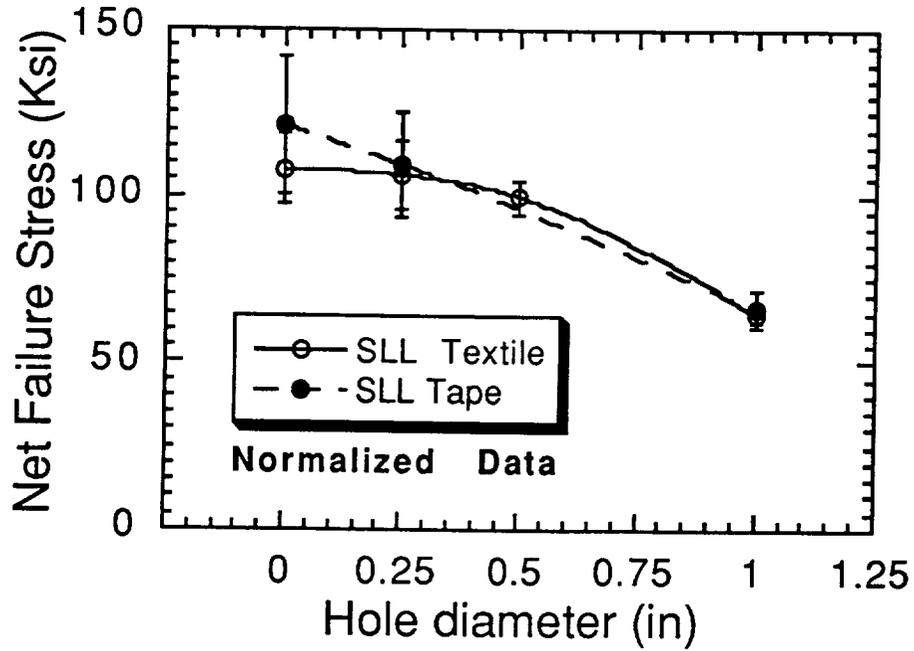
Figure 6. Net failure stress for SLL textile and tape equivalents.

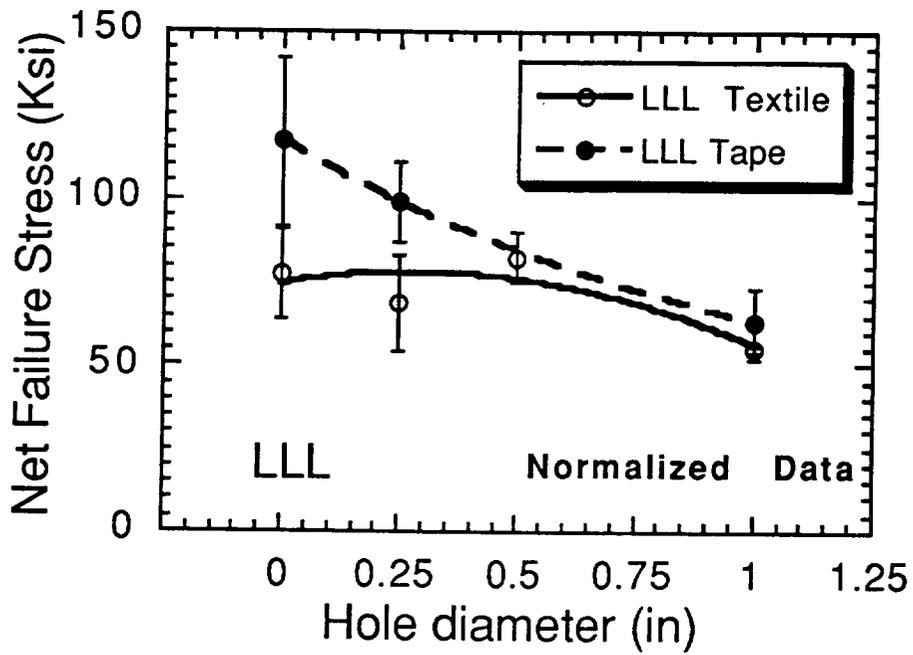
Figure 7. Net failure stress for LLL textile and tape equivalents.

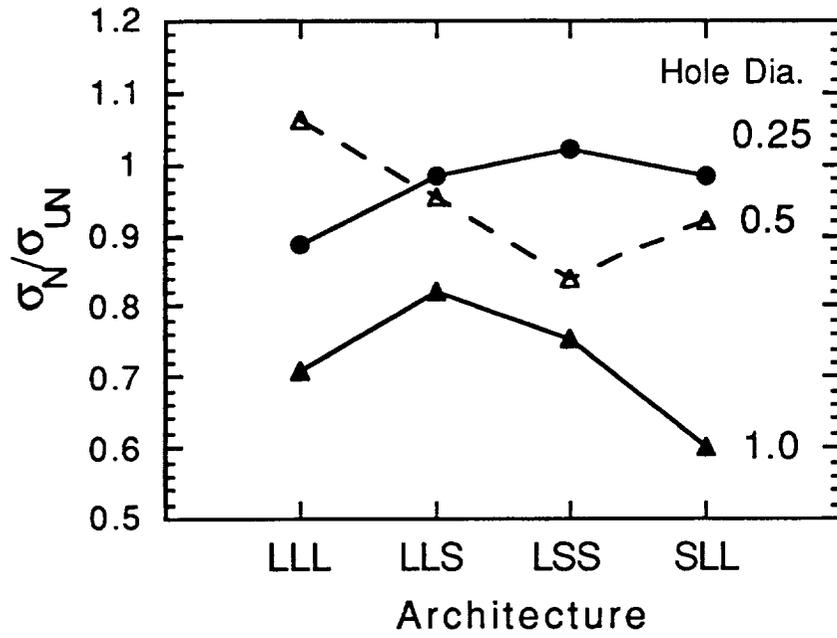
Figure 8. Architecture effect on hole size.

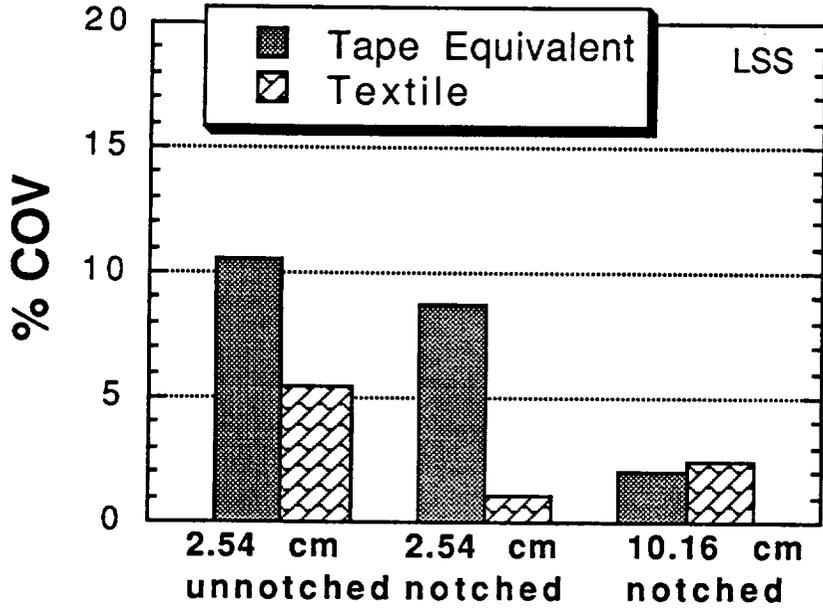
Figure 9. Coefficient of Variation (COV) of LSS textile and tape equivalents.

The coefficient of variation (COV), defined as the standard deviation divided by the mean net failure stress, is shown in Figs. 9 and 10 for the LSS and LLS architectures, respectively. It was proposed that COV could be used as an indicator of notch position sensitivity (i.e. if notched coupons exhibited larger COV than unnotched coupons for holes that are randomly placed, notch

position sensitivity is indicated). For the textiles alone, the COV's indicated that the LSS textile architecture was not sensitive to notch position whereas the LLS textile architecture was. This criteria was applied to the tape equivalents, which exhibited a similar trend. Because tape laminates should not be sensitive to notch position (due to microscopic homogeneity), we concluded that variation of COV observed between architectures was a function of material geometry and not notch position sensitivity. Thus, our criteria was not valid measure of notch position sensitivity.

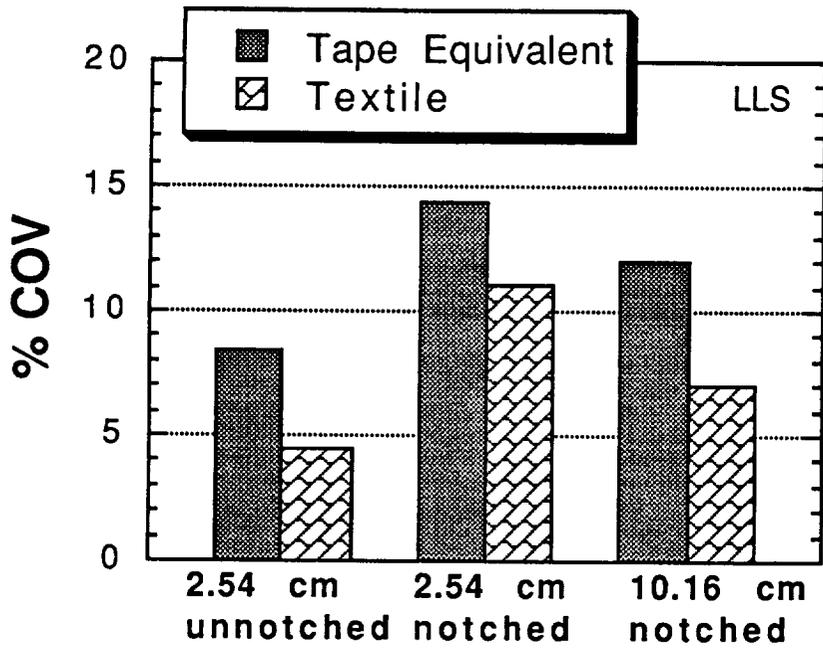
Figure 10. Coefficient of Variation (COV) for LLS textile and tape equivalents.

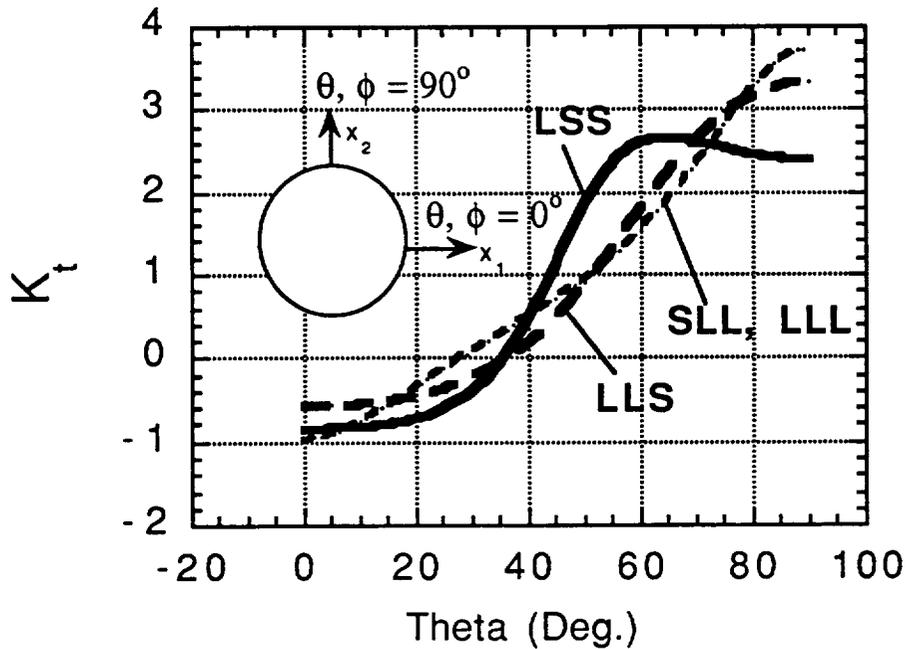
Figure 11. Stress concentration factor around a notch calculated from approximate theory for anisotropic materials using equivalent laminate material properties. The load and longitudinal direction corresponds to  $\theta = 0^\circ$ .

Using the stress concentration factor calculated for the near notch strain predictions (Fig. 11) along with the notched and the unnotched strength, equation (5) was used to calculate  $d_0$ . Shown in figures 16-19 are the notched failure data normalized by the unnotched data for the four architectures tested along with the theoretical predicted strength generated from calculated  $d_0$ . As can be seen, textiles are less notch sensitive than tape equivalents as indicated for the large values of  $d_0$  for the textiles and by the area under the stress ratio vs. hole radius curves (the textiles exhibit significantly greater  $d_0$  values and greater area under the curves than the tape equivalents). The values of  $d_0$  for the textiles are generally much larger than those for the tape equivalents.

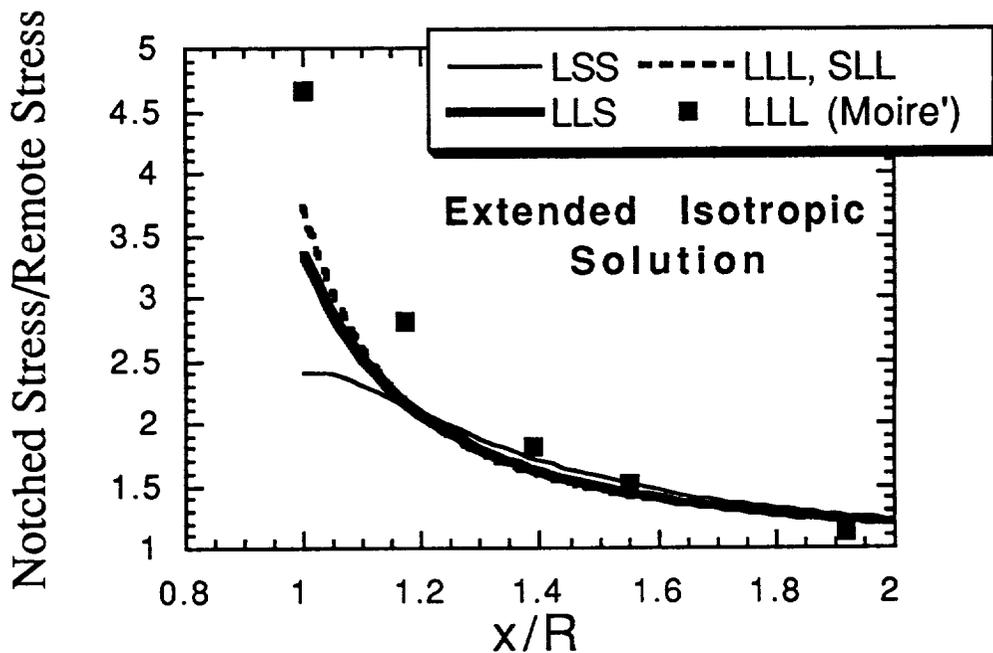
Figure 12. Approximate variation in strain away from notch in textile and tape equivalents.  $x/R = 1.0$  corresponds to the hole edge. Results obtained from Moire' interferometry are also shown for comparison [13].

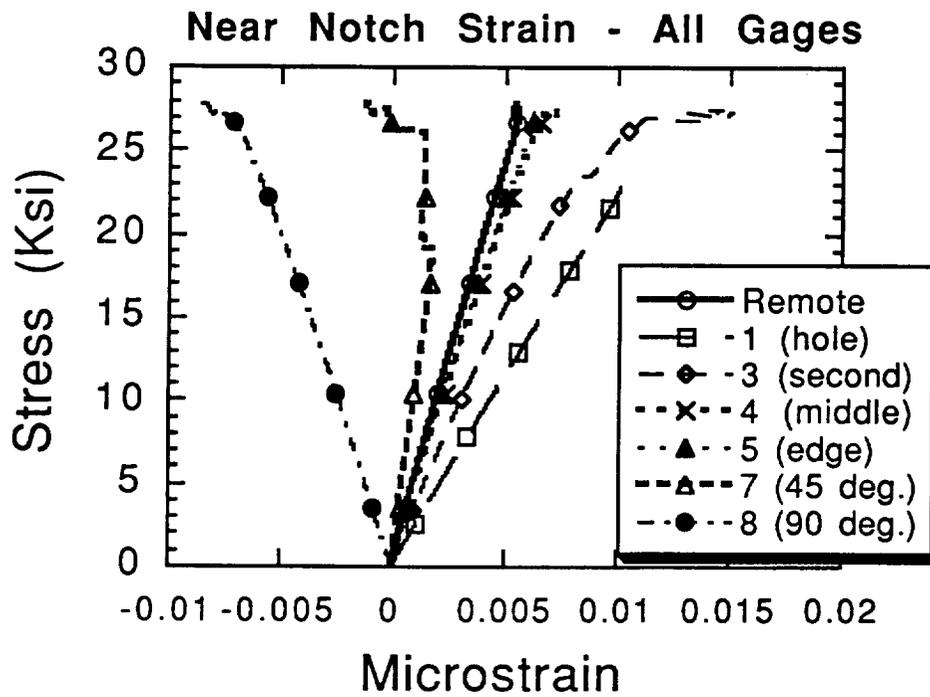
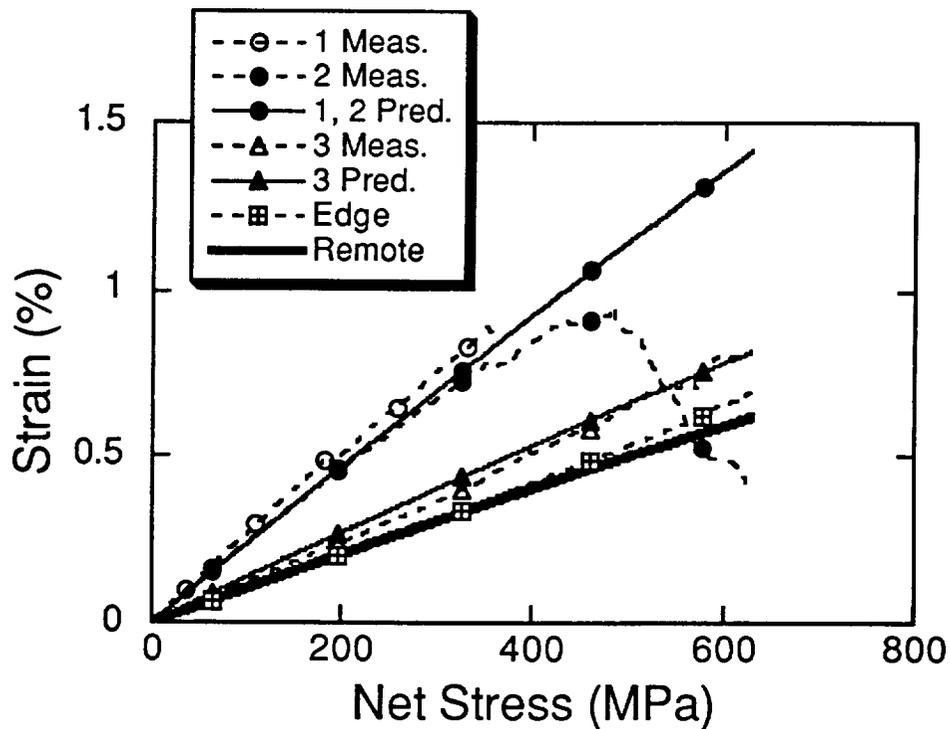
Figure 13. (a) Measured and (b) measured and predicted near notch strain. Predictions are made from remote gage strain multiplied by the approximate stress concentration factor.

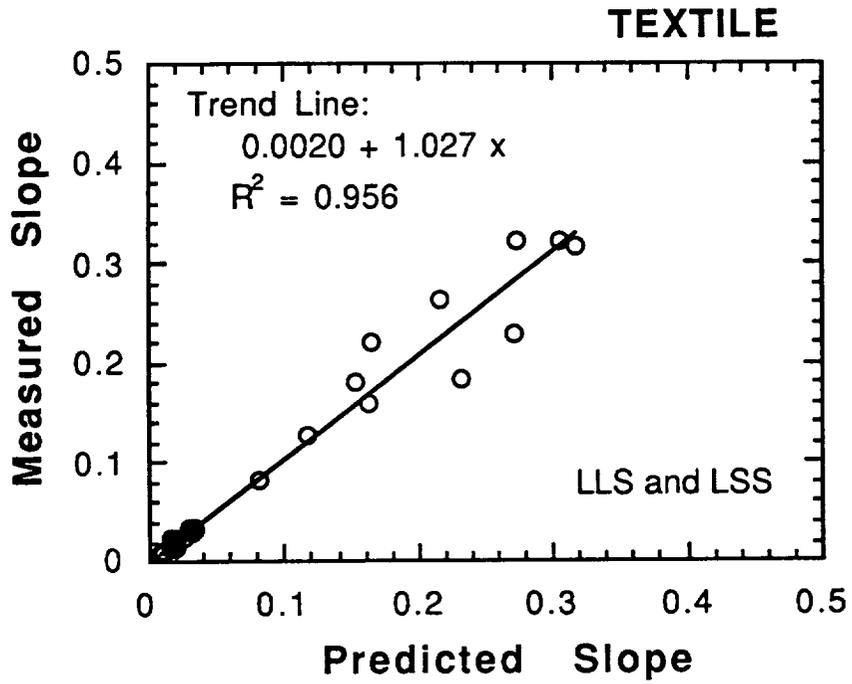
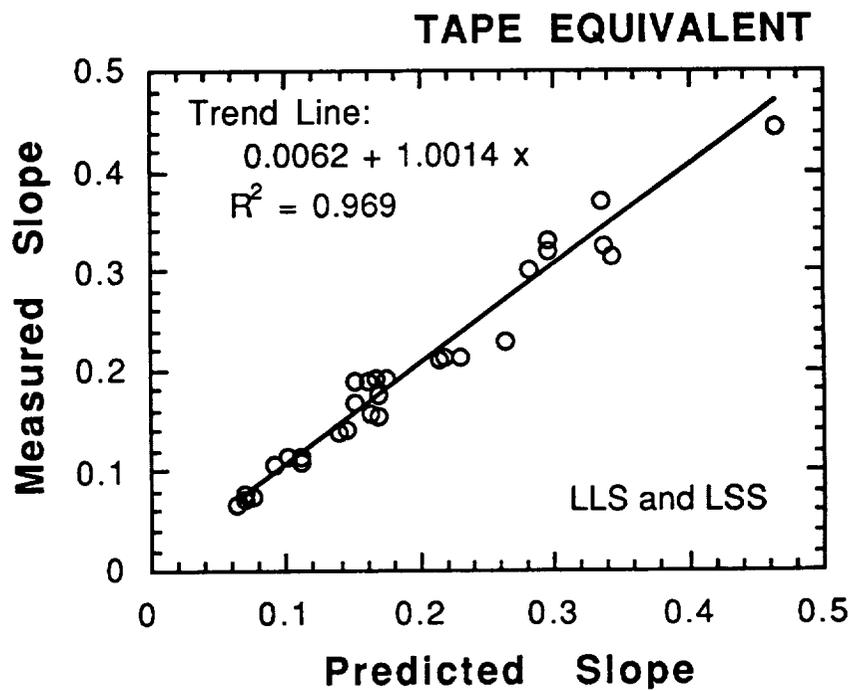
Figure 14. Correlation between measured and predicted near notch strain-stress slope for a) textile and b) tape equivalent LLS and LSS architectures.

An analysis of the slopes for observed vs. predicted was also performed (Figs. 14 and 15) for each braid angle. The  $R^2$  value of the figure is the fraction of variability in measured slope (y-axis) values which is explained by the linear relationship with predicted slope (x-axis). Results for LSS and LLS textile architectures indicated very good fits of the lines to the data (Fig. 14a). The trend line should be  $0.00 + 1.00x$ , and both approximate that quite closely. The fit is a little better for the equivalent laminated material (Fig. 14b) (seen in larger  $R^2$ ), but the differences weren't significant. Correlations for the slopes of SLL and LLL architectures (Fig. 15a) were not as good as LLS and LSS, but were within an acceptable range. Measured and predicted slopes correlated better for the SLL and LLL tape equivalents (Fig. 15b) than the braided textiles, with the  $R^2$  for the tape equivalents roughly equal to that of the LLS and LSS architectures, but the differences between tape and textile were not significant. These data suggests that the strength of predictions of near notch stress decreases with increasing braid angle for textiles.

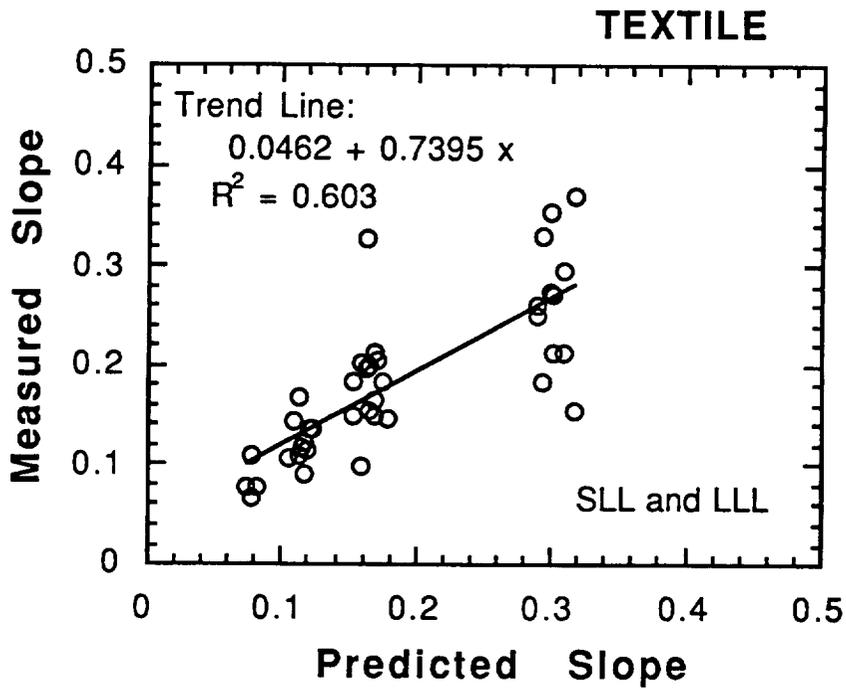
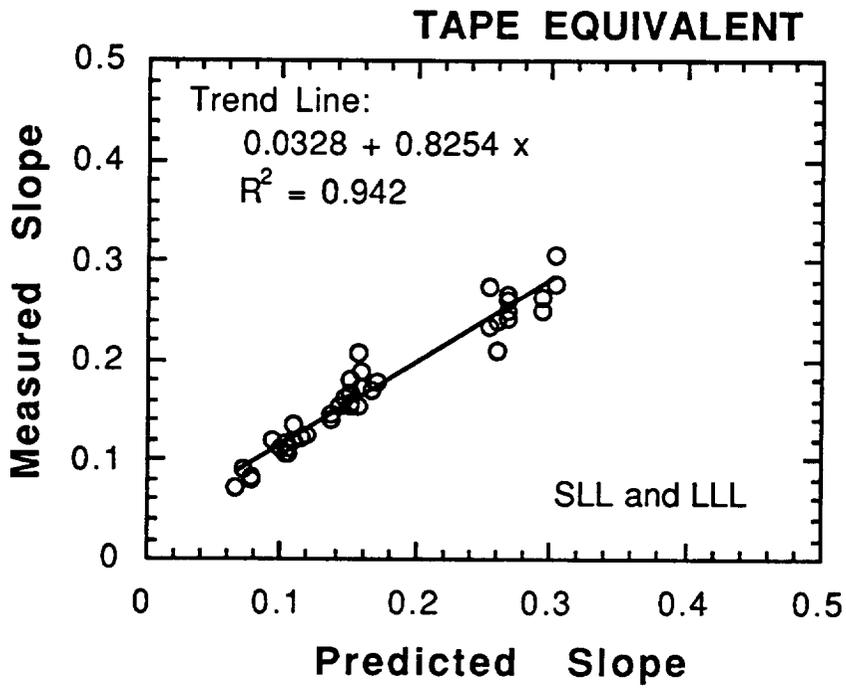
Figure 15. Correlation between measured and predicted near notch strain-stress slope for a) textile and b) tape equivalent of SLL and LLL architectures.

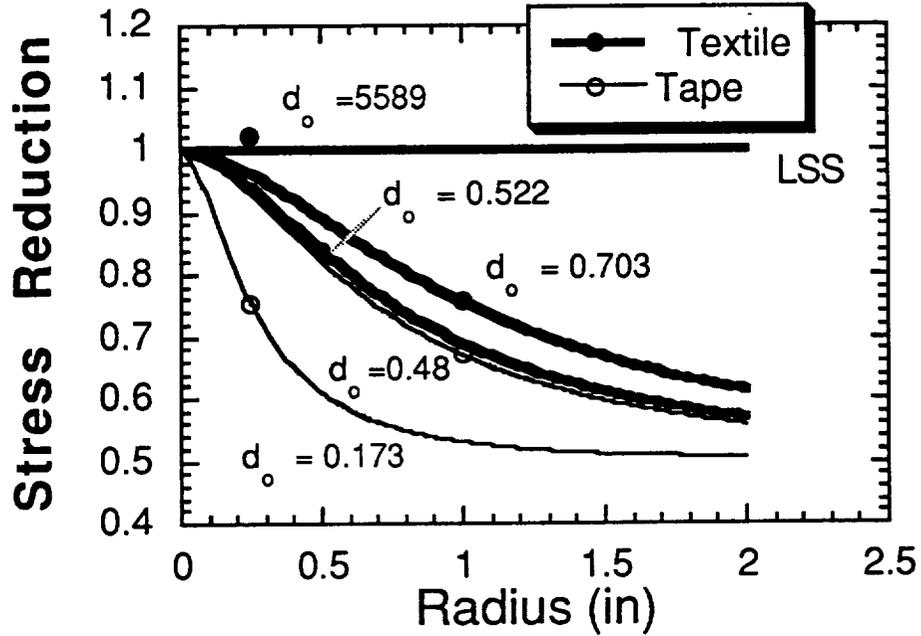
Figure 16. Point stress failure criteria for LSS textiles and tape equivalents.

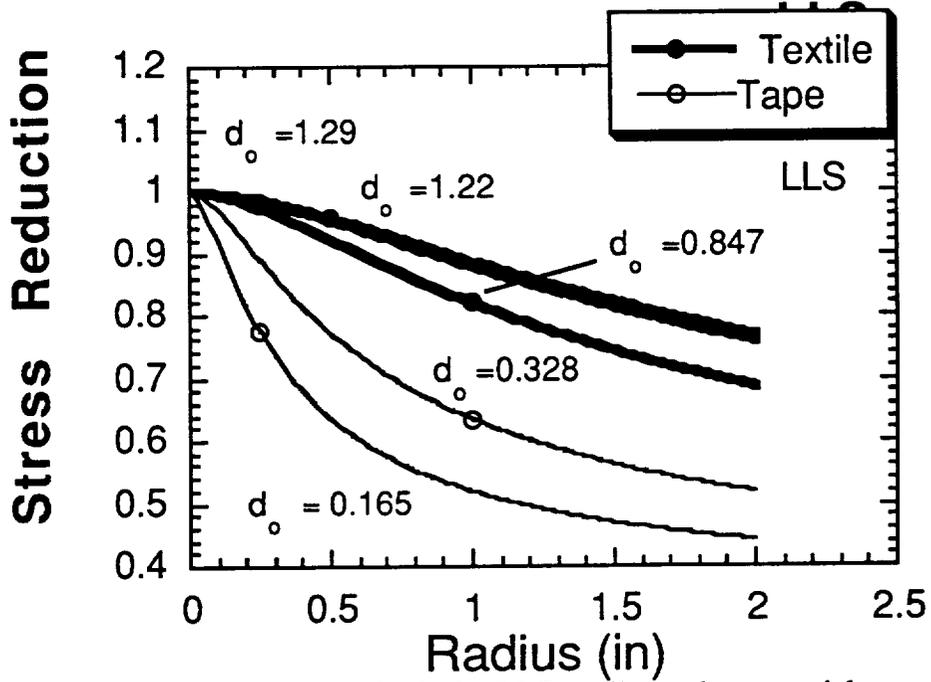
Figure 17. Point stress failure criteria for LLS textiles and tape equivalents.

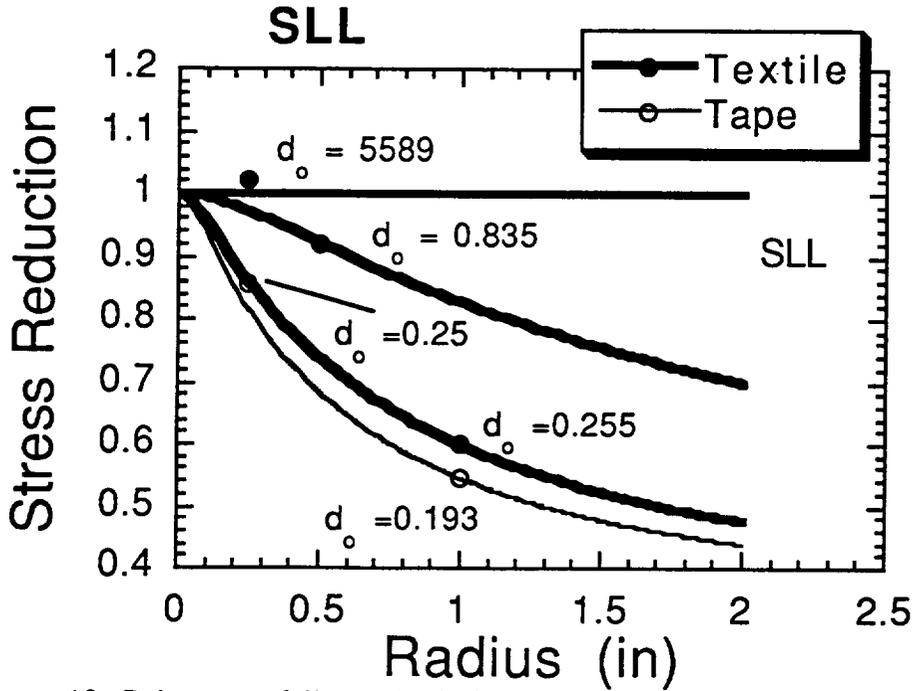
Figure 18. Point stress failure criteria for SLL textiles and tape equivalents.

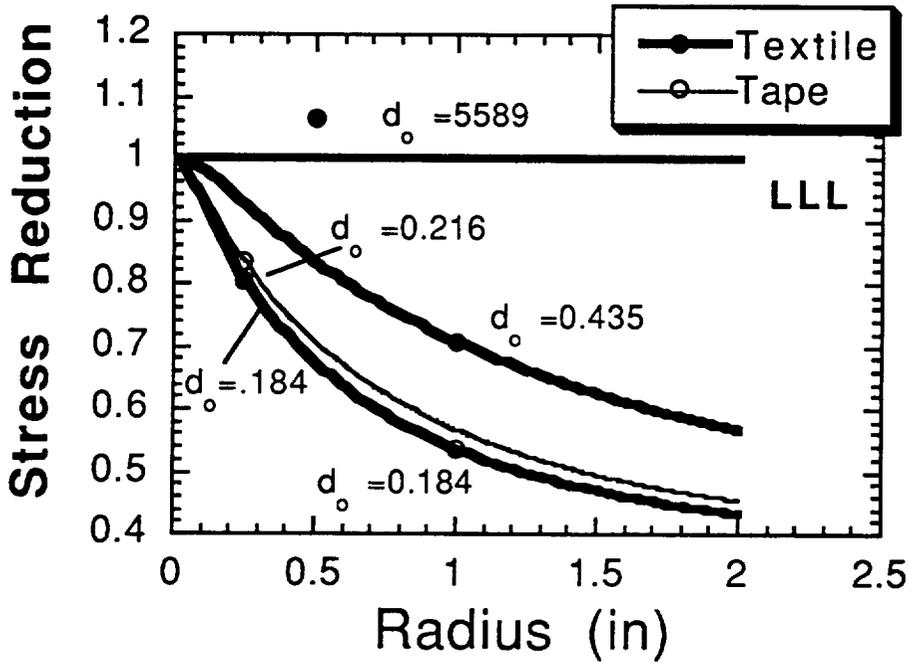
Figure 19. Point stress failure criteria for LLL textiles and tape equivalents.

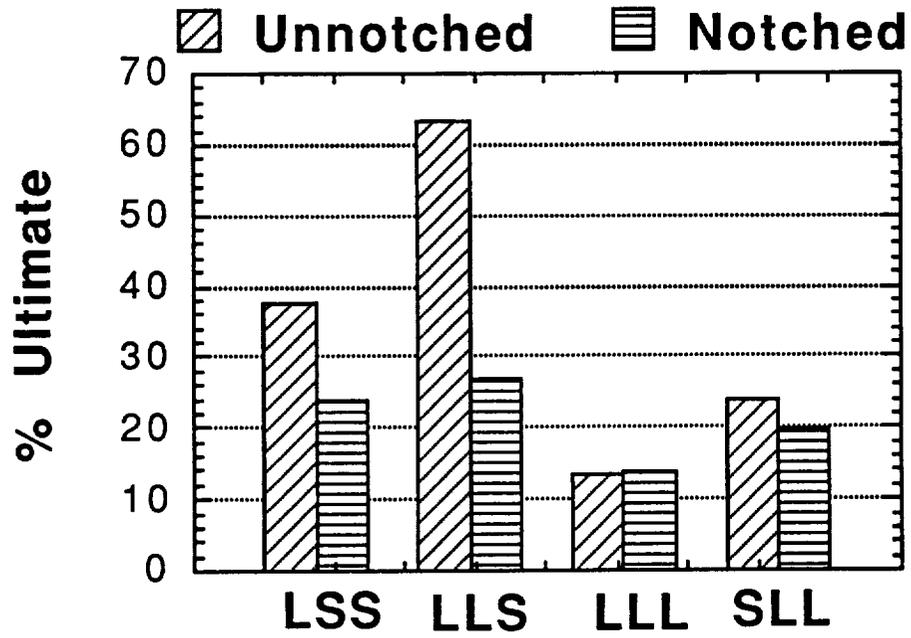
Figure 20. Damage initiation stress for 1" wide textile coupons expressed as % ultimate.

Damage initiation stress of 1" notched and unnotched textiles coupons was determined using the radiographs of specimens taken at small intervals of loading (Fig. 20, Table 9). The initiation stresses were normalized to the ultimate failure stress of the notched and unnotched coupons. The data in the figure indicates that damage initiation level and the difference between notched and unnotched initiation stress decreases with increasing braid angle.

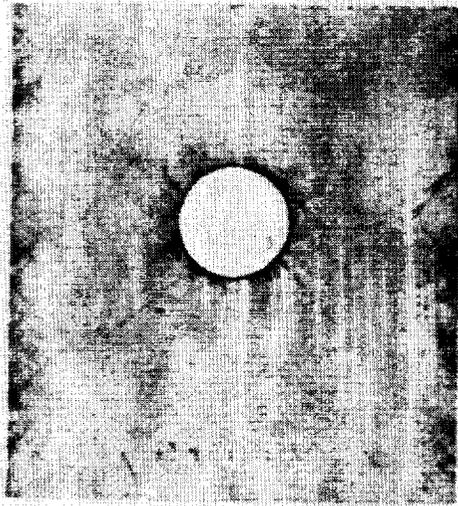
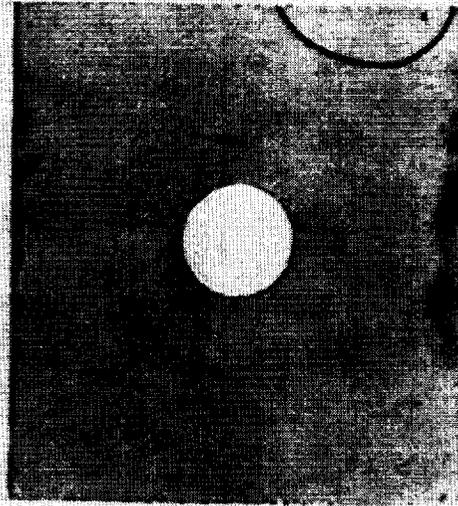
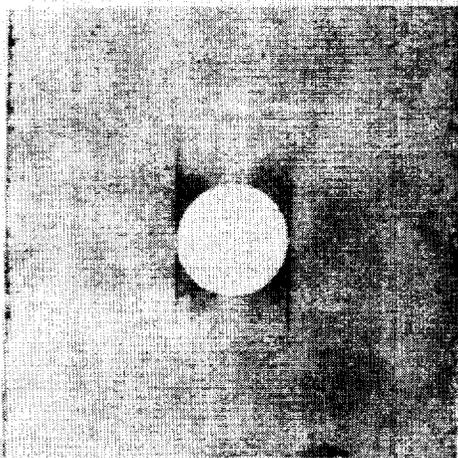
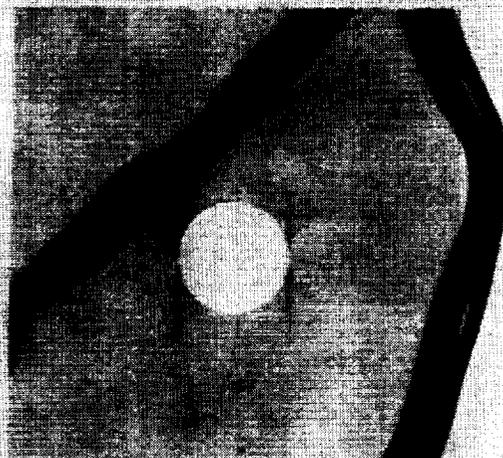
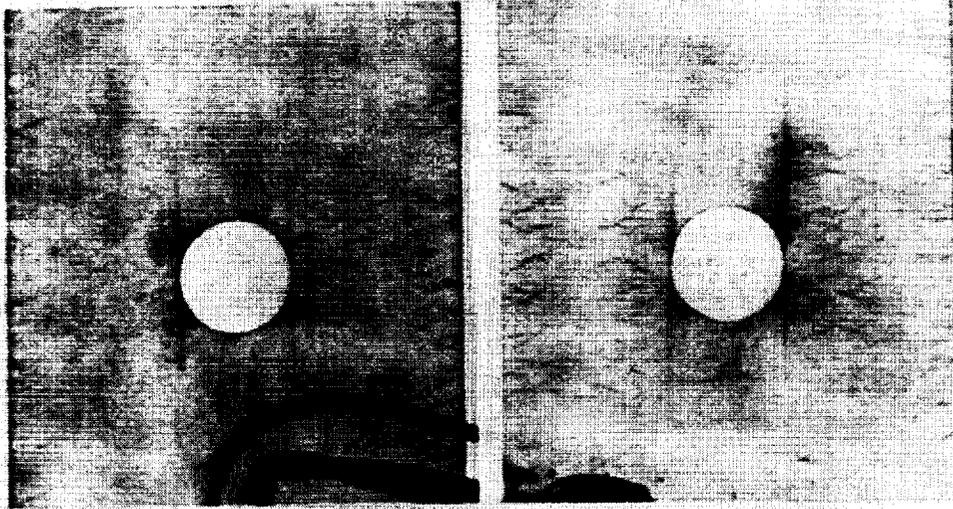
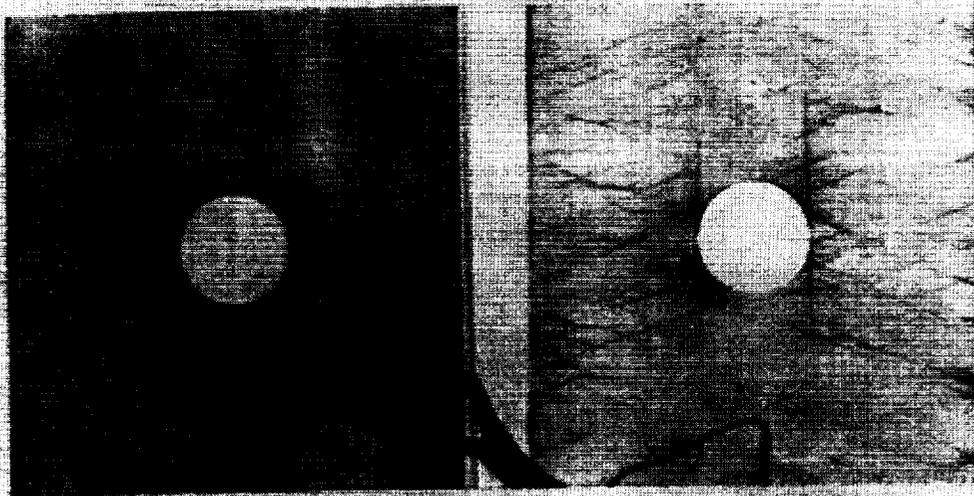
Figure 21. Radiographs of textile and tape equivalents at 75% of ultimate failure stress with architectures corresponding to a) LSS, b) LLS, c) SLL and d) LLL.

Radiographs for notched textile and tape equivalent coupons at 75% of failure stress are shown in Fig. 21. These radiographs show cracking along the braid angle in all textile and tape equivalents and longitudinal cracking in the longitudinally dominated architectures (LLS, SLL and LLL, tape and textiles). A 45° section of an LSS notched coupon at 75% of failure stress shows that cracking along the braider yarn angle is braider yarn splitting and occurs through the thickness (Fig. 22), similar to cracking observed along the coupon edge. A transverse section of a notched LLS textile coupon (Fig. 23) shows the location of the longitudinal crack identified at the hole edge (Fig. 21b). The cracking is identified as longitudinal yarn splitting. In the tape equivalent coupons (Fig. 24), the longitudinal crack was within the 0° plies. The cracks in the 0° plies of tape equivalents propagated to the interface between the angle plies and 0 degree plies and then propagated to the hole edge, indicated by the shaded region in the radiographs (Fig. 21b,c,d). In the textiles, however, the longitudinal cracks propagated to the yarn edge, and in some cases to an adjacent yarn, where they were suppressed from further propagation.

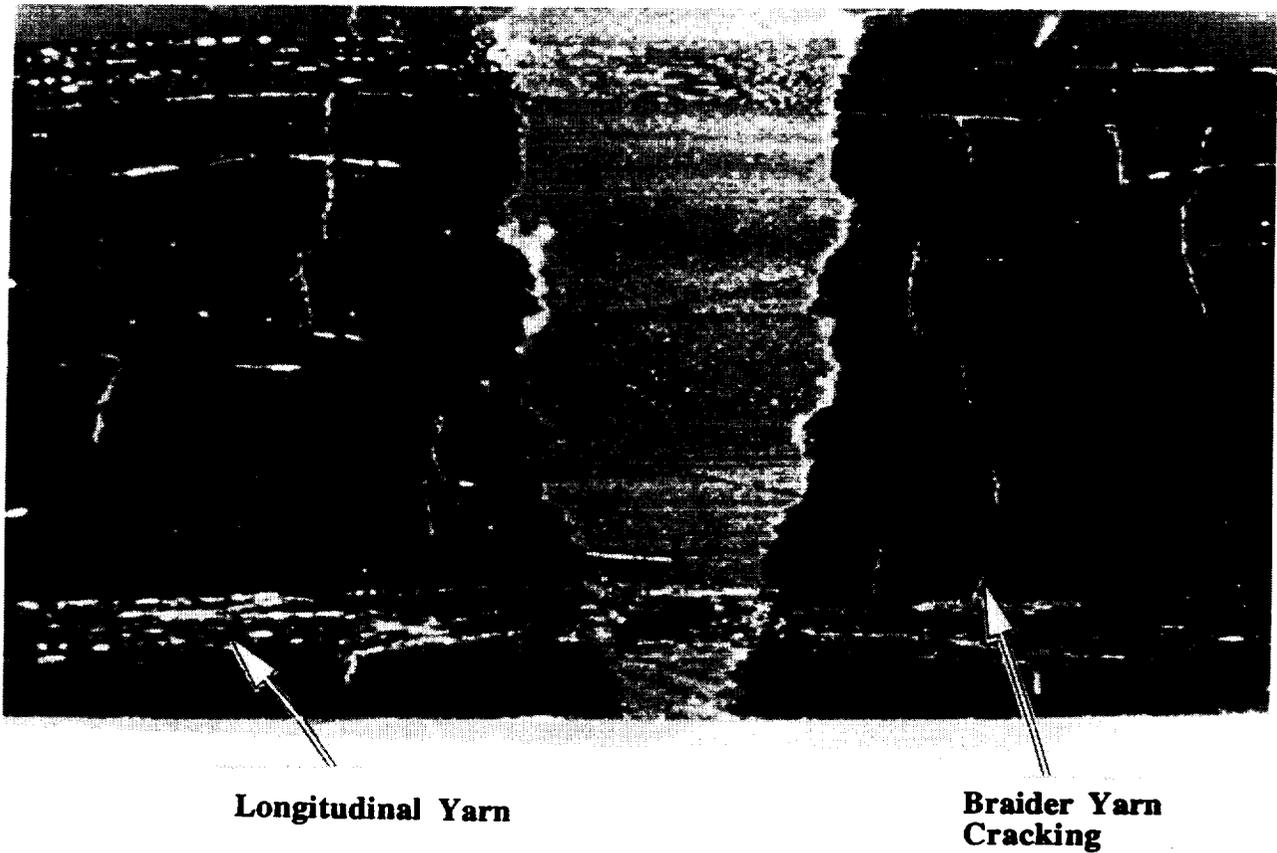
Figure 22. 45° section (Fig. 4) of a LSS notched coupon at 75% of failure stress looking out from the inside of a hole along the braider yarn direction. Cracking in the braider yarns is observed at the notch through the thickness similar to edge cracks of unnotched coupons. The nominal thickness is 3.175 mm.

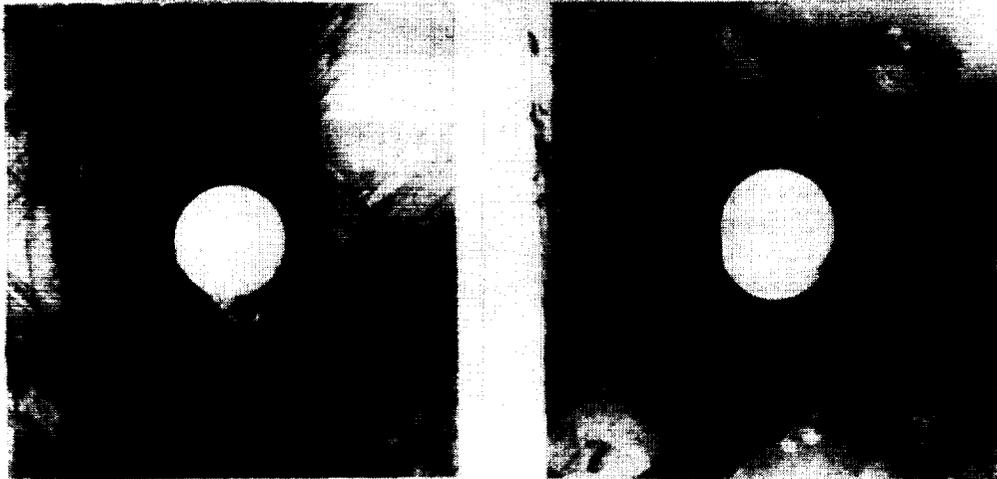
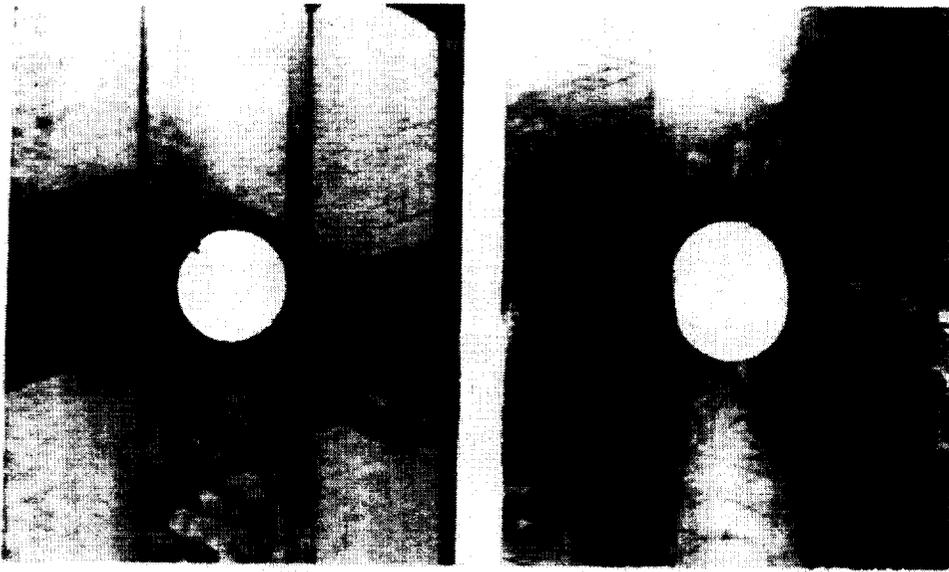
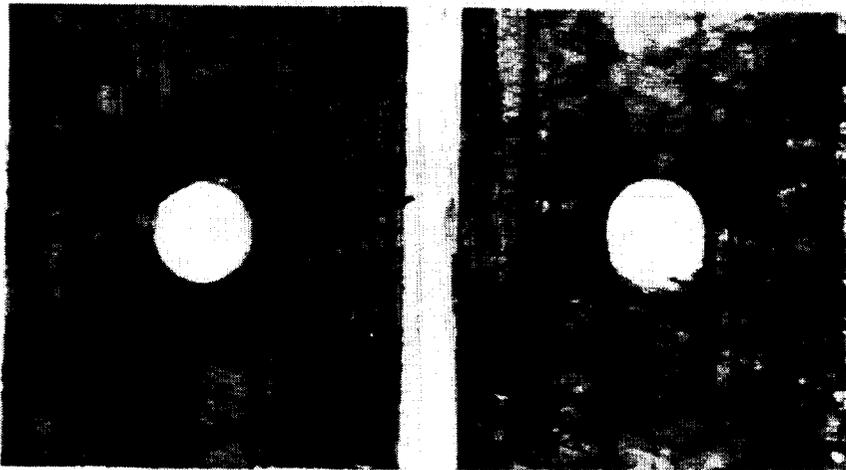
Figure 25. Radiographs of textile and tape equivalents at failure with architectures corresponding to a) LSS, b) LLS, c) SLL and d) LLL.

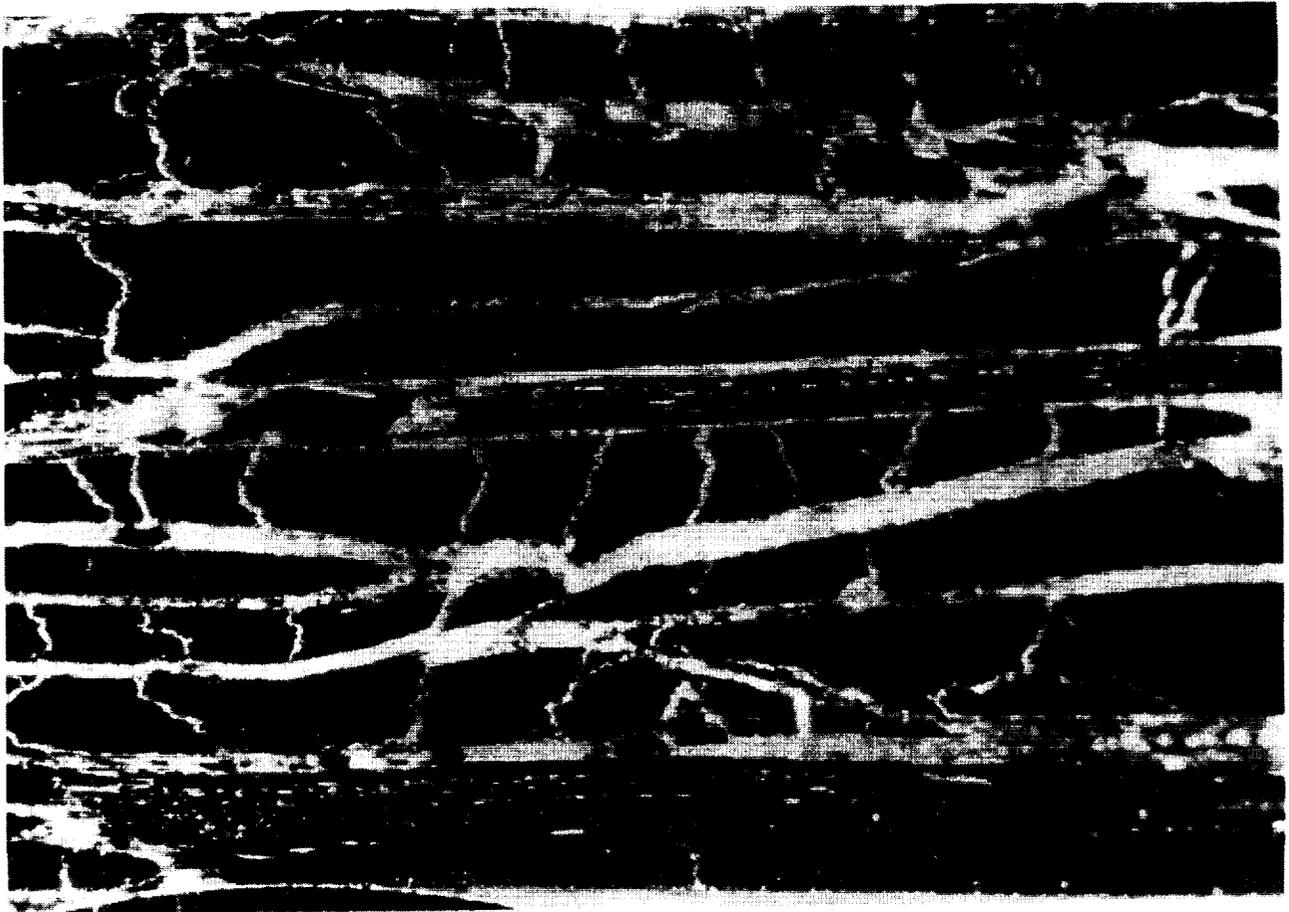
Figure 26. Longitudinal photomicrograph of an LSS unnotched coupon at failure. Extensive cracking in braider yarns and delaminations of the braider and longitudinal yarns are observed. The nominal thickness is 3.175 mm.

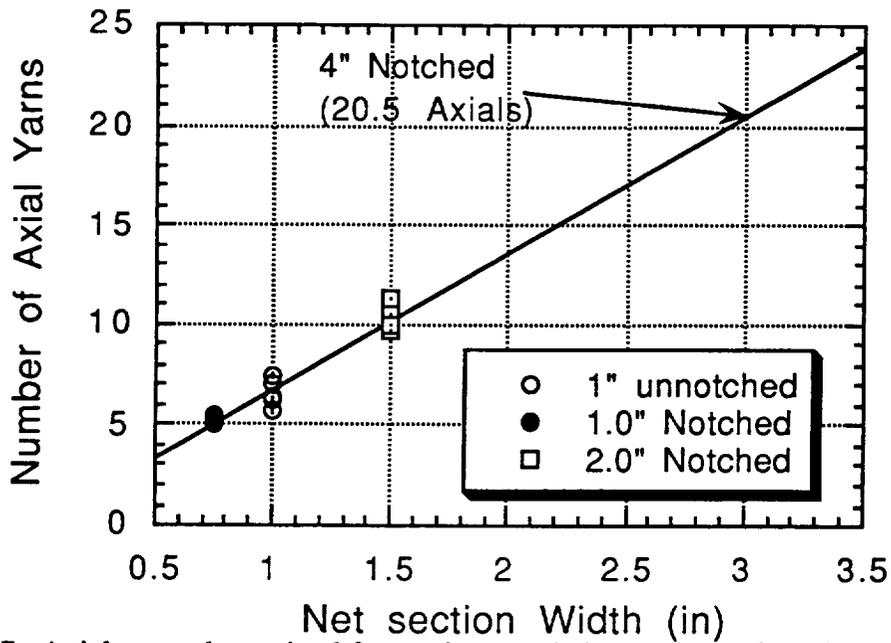
Figure 27. Axial yarns determined from microscopic inspections of tensile specimens. The number of longitudinals for the 4" notched specimens is found from extrapolation.
